Swift BAT Loop Heat Pipe #0 Temperature Droop Problem and Solution after Its Primary Heater Controller Failure

Michael K. Choi*

NASA Goddard Space Flight Center, Greenbelt, MD 20771

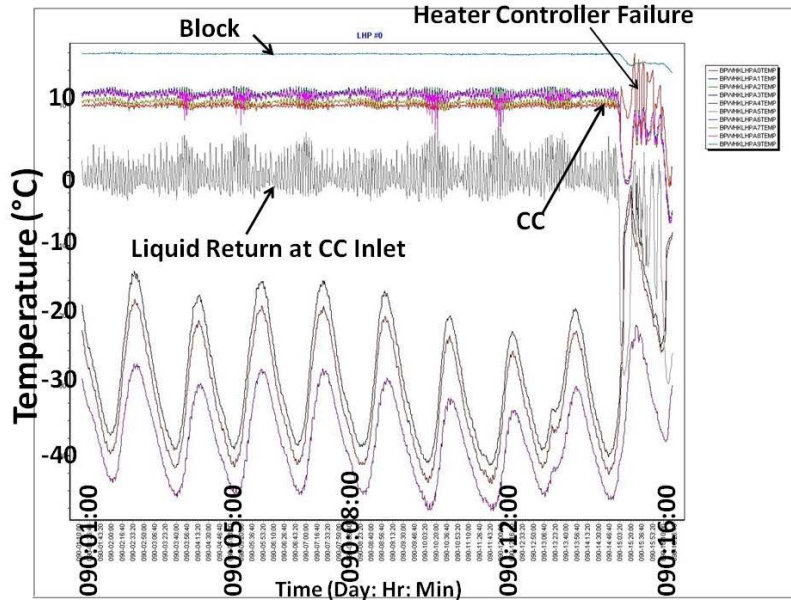
Figure 9. LHP #0 and Block Temperatures on Day 90 (March 31), 2010.

On March 31 (Day 90), 2010, the primary heater controller of LHP #0 failed. The LHP #0 CC temperature decreased rapidly and activated the secondary heater controller circuit. Note that the primary heater controller is Side A and the secondary heater controller is Side B of the same board (Figure 8).⁵ The set point of the secondary heater controller was 6°C, which was 2°C lower than that of the primary heater controller. After the secondary heater circuit was activated, LHP #0 had temperature instability and a temperature droop every orbit (Figure 9). The temperature instability was caused by cold shock and much lower heater controller set point than that of LHP #1. It led to temperature instability on LHP #1 (Figure 10).

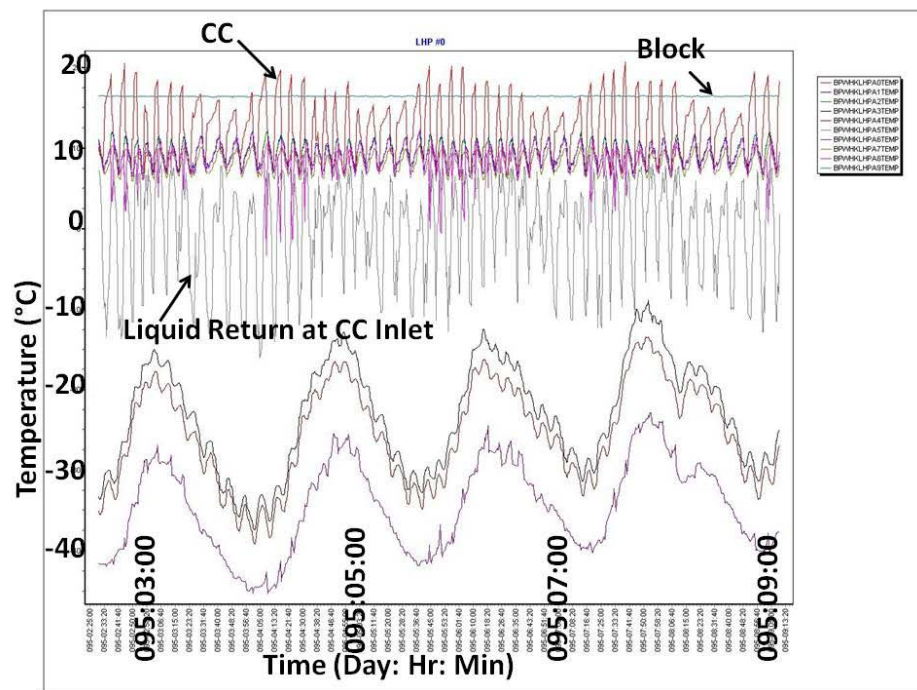
Figure 11. LHP #0 and Block Temperatures on Day 95 (April 5), 2010.

On April 3, 2010, the LHP #0 primary heater controller was disabled and the set point of LHP #0 secondary heat controller was increased from 6°C to 8°C. From the CC temperature in Figure 11, the secondary heater controller had a significantly larger tolerance than that of the primary heater controller in Figure 8. The AD590 temperature sensor for housekeeping telemetry and the thermistor for feedback to the heater controller are both adjacent to the heater (Figure 12). Secondly the temperature of the liquid return at the CC inlet had a wider range than that before the primary heater controller failed. Thirdly the Block temperature was colder than before the heater controller failure. On April 6, a temperature droop occurred. It recovered in one orbit (Figure 13). Also telemetry BPWHLHPA5TEMP violated the alarm low limit. This temperature sensor measures the temperature of propylene liquid at the LHP CC inlet, where liquid returns to the CC from the VCHP heat exchanger (Figures 14 and 15).

It appears that the LHP #0 secondary heater controller set point tolerance was out of specifications. The tolerance in the specifications is no larger than $\pm 0.25^{\circ}\text{C}$.⁶ Because the heater controller tolerance far exceeded the specification, it had the following consequence. At the coldest attitude and in the eclipse when the temperature of the liquid return from the VCHP heat exchanger to the CC was not sufficiently pre-conditioned, a temperature droop occurred. If the VCHP heater controller is a separate controller (i.e., not a channel of the LHP heater controller), the temperature of the liquid return from the VCHP heat exchanger to the CC could be controlled adequately to prevent a temperature droop. On April 6, 2010, the set point of LHP #0 secondary heat controller was increased to 8.25°C .

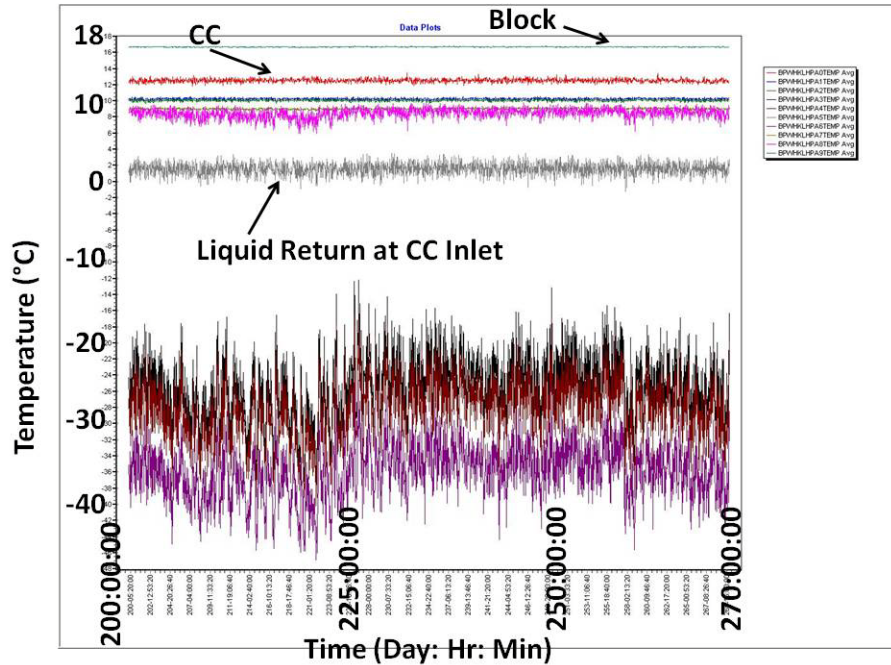
Figure 19. LHP #0 and Block Temperatures from Day 200-285, 2010.

On May 18, 2010, the set point of the LHP #0 secondary heat controller was increased from 8.5°C to 8.6°C. Afterward, there was no temperature droop between May 18 and June 11. The LHP #0 evaporator temperature was still about 0.1°C colder than that before the March 31 primary heater controller failure. Therefore on June 11, the LHP #0 secondary heater controller set point was increased to 8.7°C to enhance the VCHP heater control and to raise its evaporator temperature to that before primary heater controller failure. There was no temperature droop for more than 4 months (Figure 19).
